DOT/FAA/AR-97/65

Stabilized Base Courses for Advanced Pavement Design Report 1: Literature Review and Field Performance Data

September 1999

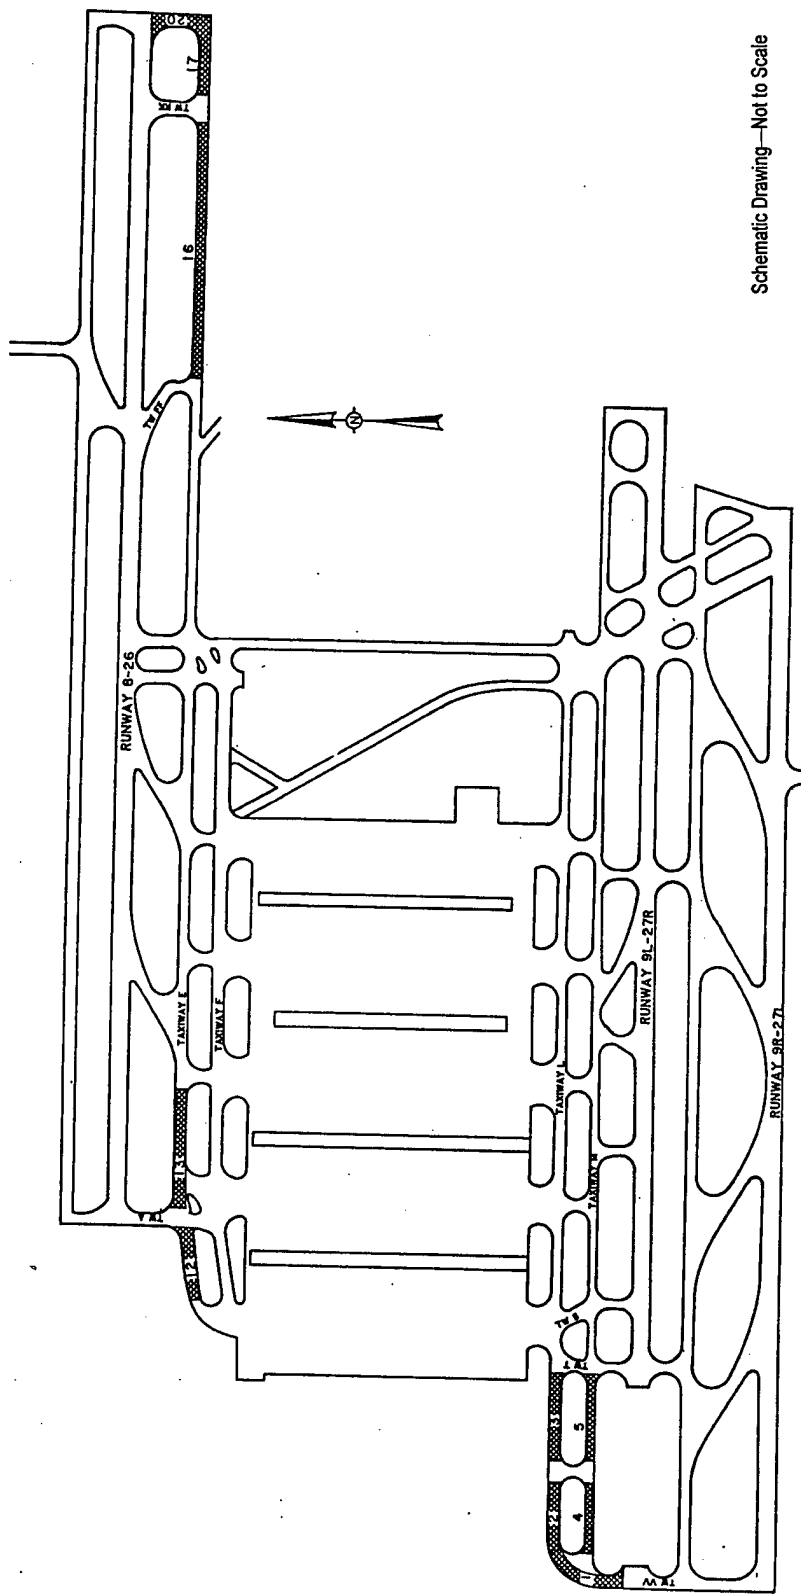
FIGURE C-1. LAYOUT OF ATLANTA INTERNATIONAL AIRPORT

Schematic Drawing—Not to Scale

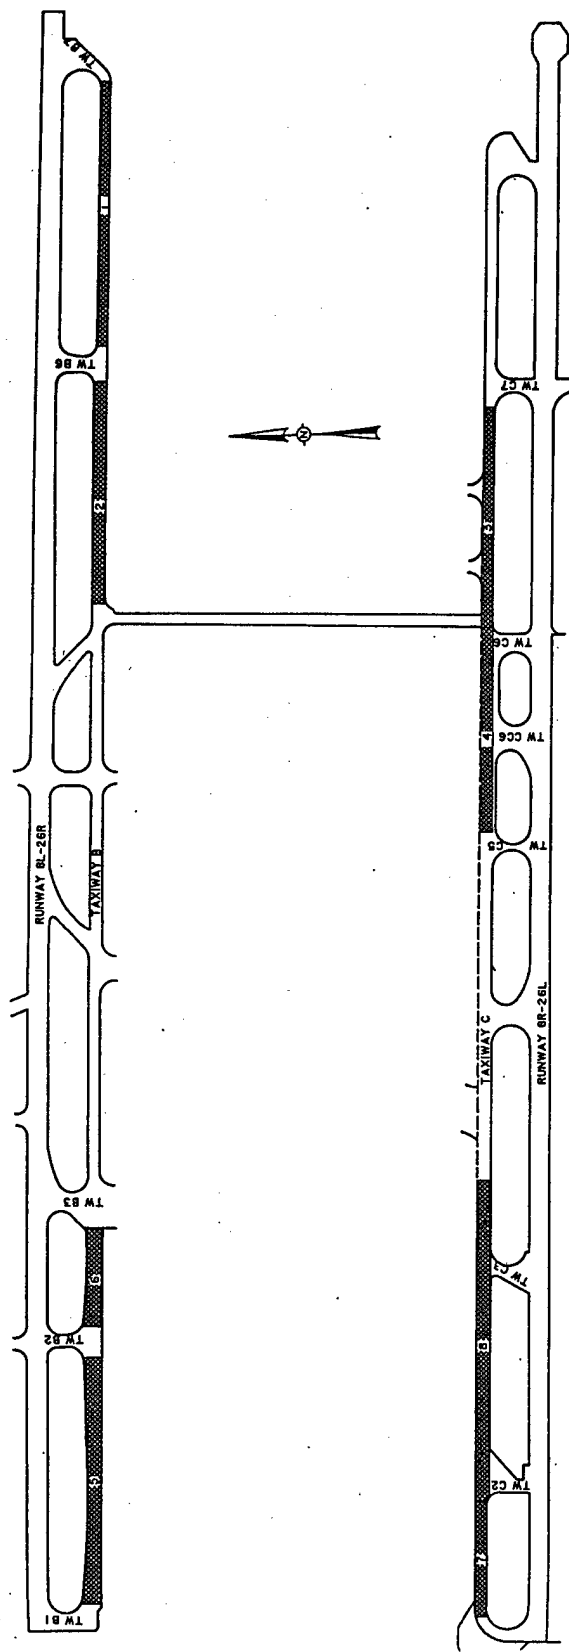
FIGURE C-4. LAYOUT OF PHOENIX SKY HARBOR INTERNATIONAL AIRPORT

Schematic Drawing—Not to Scale
